Project Report
Optical Image Profiler (OIP) Logging
Brooklyn, MI Test Site

March 15, 2016

Optical Image Profiler (OIP) Project Report

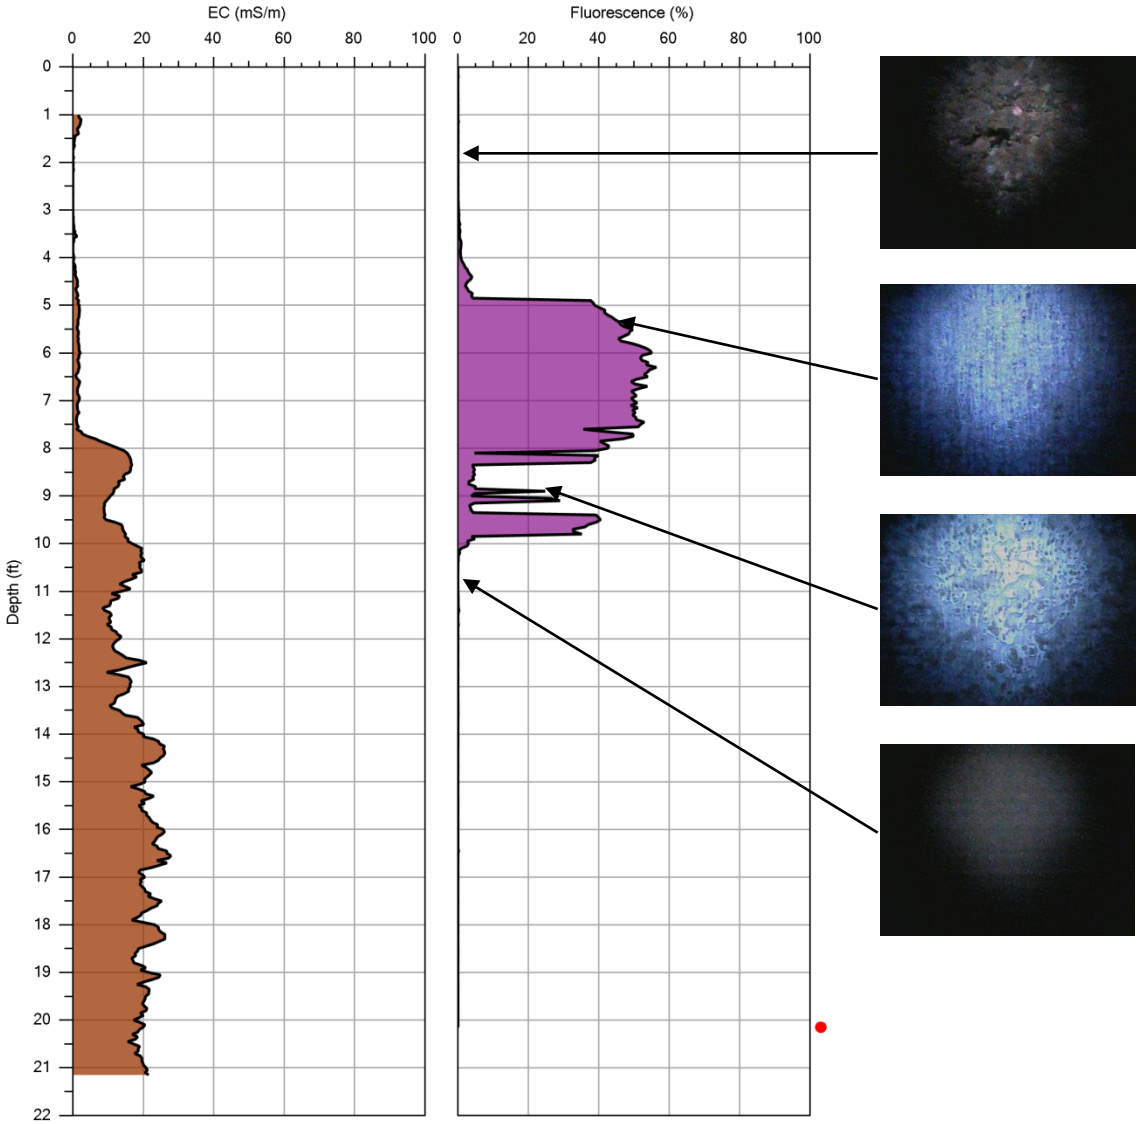
Figure 5: Log GL-25 with UV images from 1.95ft (0.59m), 5.35ft (1.63m), 8.85ft (2.7m) and 10.60ft (3.23m).

Baseline values on OIP logs are typically less than <1% in areas with no detectable hydrocarbon NAPL impacts. At locations with hydrocarbon impacts, OIP fluorescence typically ranged from 15% up to 75% of the image area. Figure 5 shows log GL-25 and select images from the log. Included in these images are both non-fluorescent (background) soils and areas of high fluorescence (hydrocarbon impact).

The image in figure 6 is from Log GL-25, 8.85ft (2.7m) (shown in Figure 5). This image shows fuel fluorescence in soil below the water table. This image illustrates fuel as an immiscible phase in water. The fuel has separated from the soil particles and is pressed over the face of the window with water as its surrounding matrix.

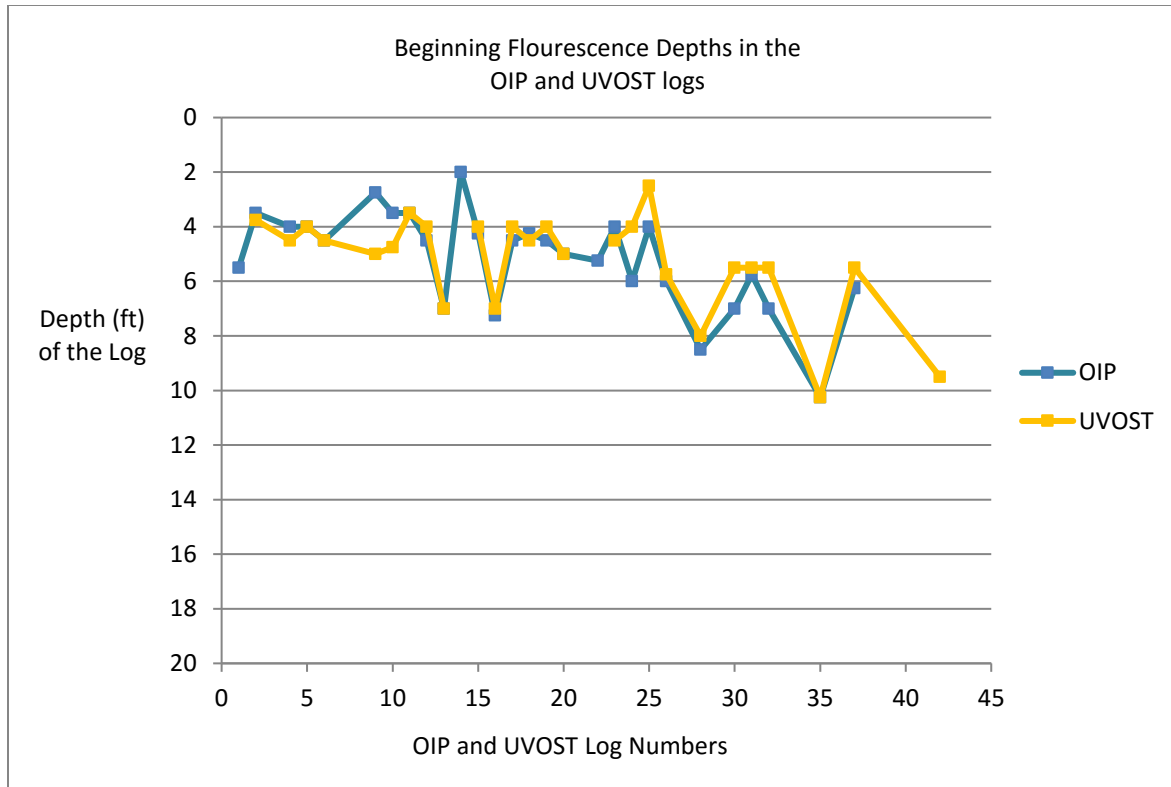
Figure 7: Chart of the beginning depths of detected fluorescence in the OIP and UVOST® logs.

Beginning and ending depths of detected fluorescence are shown in Figures 7 and 8. These graphs show how closely the two technologies agree in assessing the thickness of the predominant hydrocarbon NAPL impacts starting at depths greater than 2 ft. (0.6m) at the site. A >5% signal cutoff was used to determine where the beginning and ending points of log fluorescence in the graphs. Missing data points or lines in either of the graphs indicate that fluorescence signal above the cutoff was not detected at that location for that technology.

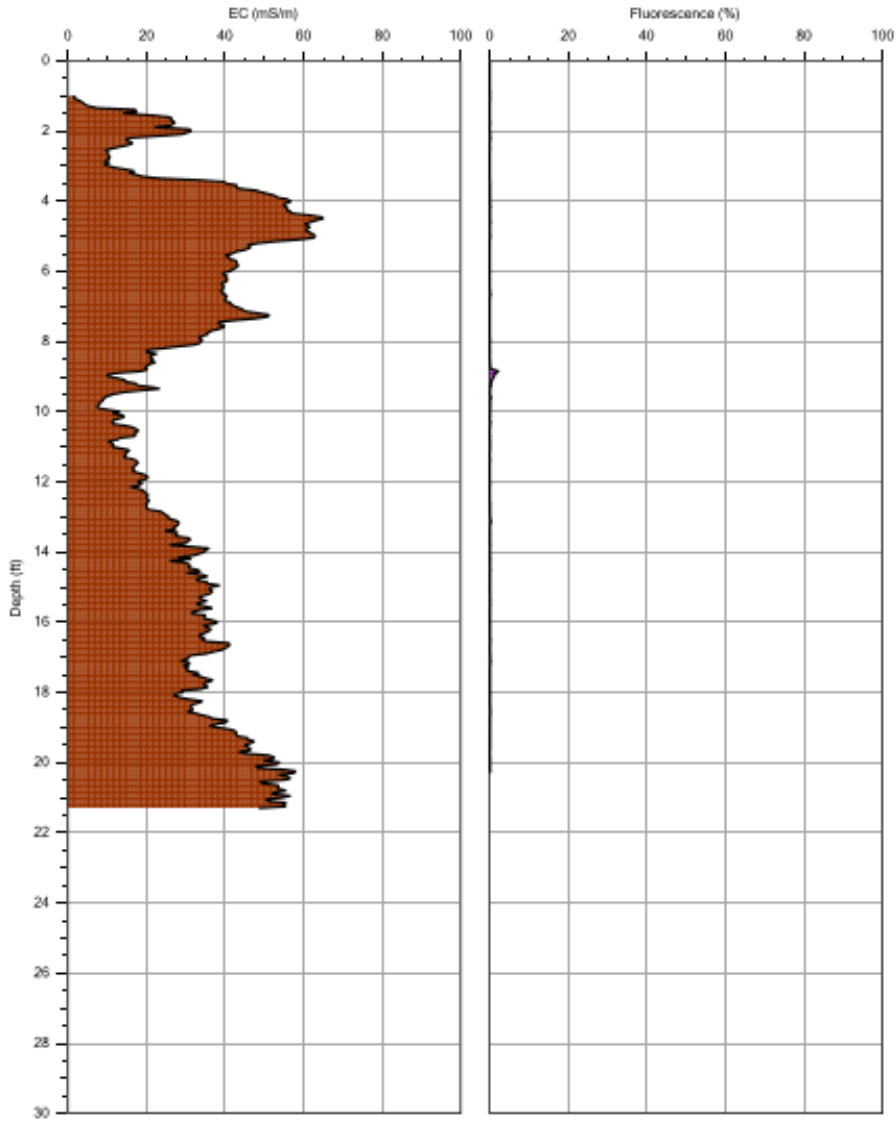
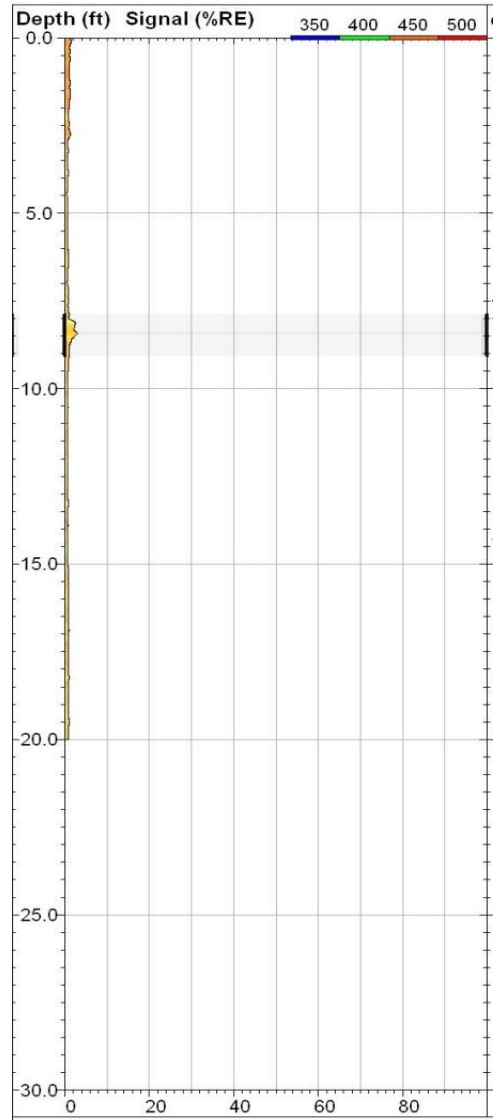
Company: Geoprobe Systems	Operator: DAP	File: GL-01.DEC
	Project ID: OIP Field Test	Client:	Date: 2/1/2016
			Location:

Appendix B provides graphs of co-located OIP and UVOST® logs for each location. On each page, the location EC and OIP fluorescence (% image area) along with the co-located UVOST® fluorescence (%RE) log are shown.

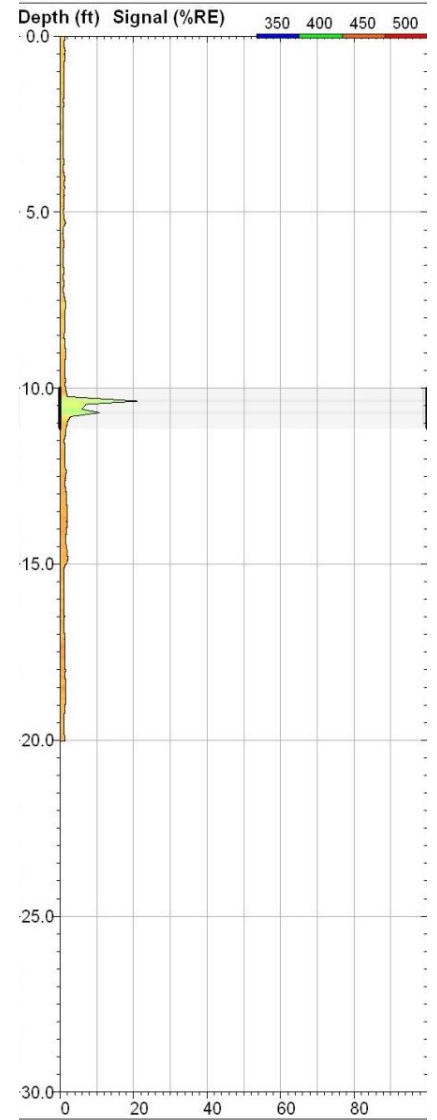
LIF-35

UVOST Log

Company:	Geoprobe Systems	Operator:	DAP	File:	GL-35.OEC
Project ID:	OIP Field Test	Client:		Date:	2/3/2016
				Location:
