Field Tests with the OIP-Green DP Photo-Logging System for Detection of Coal Tars

Wesley McCall*, Thomas M. Christy, Daniel A. Pipp, Ben Jaster¹

1)Geoprobe Systems, Salina, KS 2)GSI Engineering, Wichita, KS 3)Kansas Dept. Health & Env., Topeka, KS

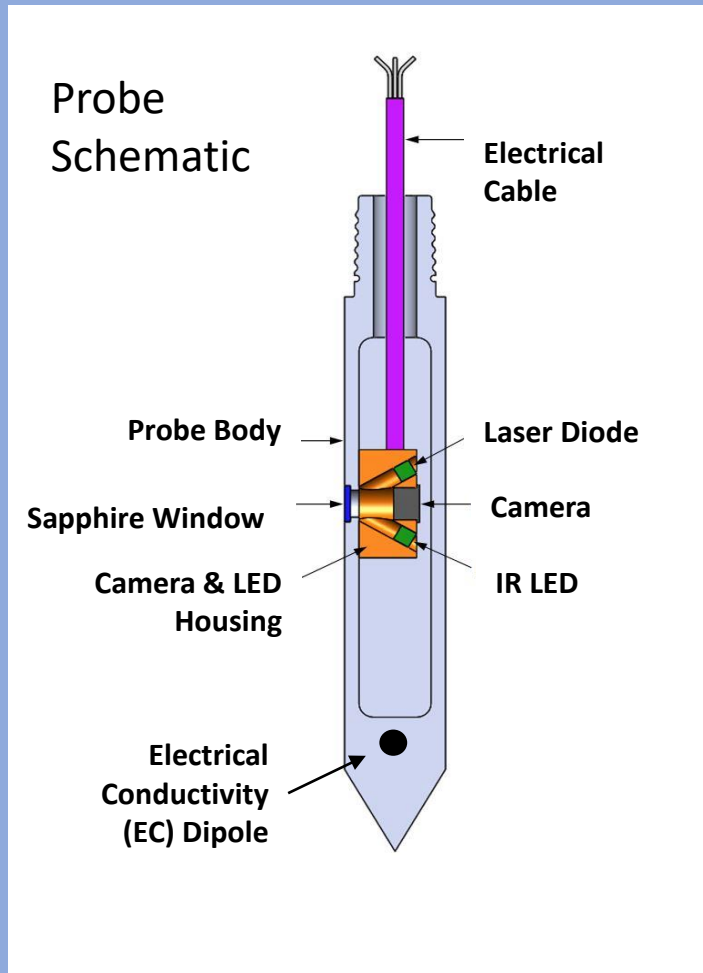
The OIP-G Probe

- The green laser diode (520nm) illuminates the formation outside of the sapphire window while logging.
- Nonaqueous phase contaminants like coal tar, creosote and some heavy fuels will fluoresce in the red wavelength range.
- The CMOS* camera captures images at 30 frames per second (fps) for analysis by the program software to identify fluorescence.
- The infrared (IR) light emitting diode (LED) is used at desired depths to observe formation texture and grain size.
- The EC dipole provides a log of bulk formation electrical conductivity which may help define lithology.

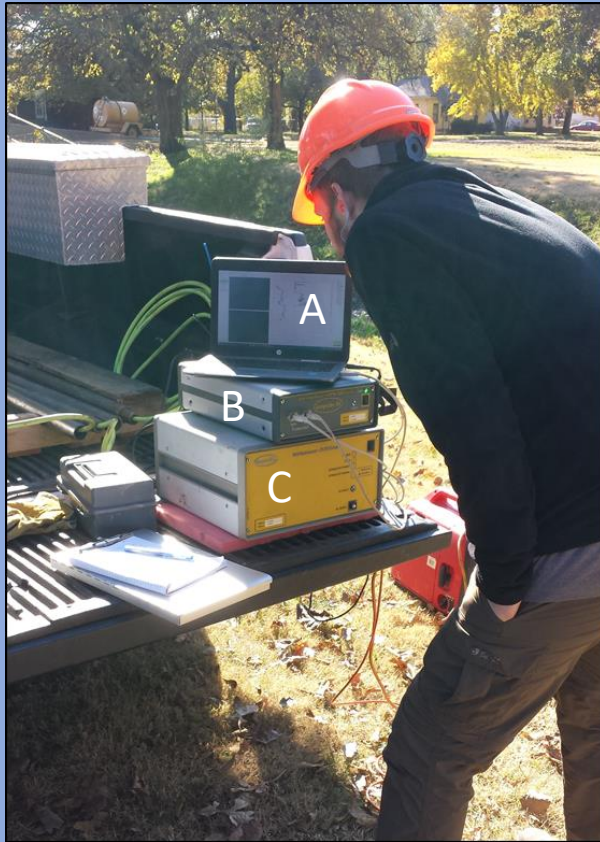
The logs of fluorescence (FL) and electrical conductivity (EC) are viewed live time along with the images of fluorescence as the probe is advanced.

Images of in-situ fluorescence (I-1) are displayed live time along with the software analysis (I-2) of the image. A 2-stage digital filter is used to define the percent area exhibiting fluorescence.

- A) laptop computer with Acquisition software
- B) OIP Interface (OIP6100)
- C) Field Instrument (FI6000)

Portable generator (not shown) powers the system

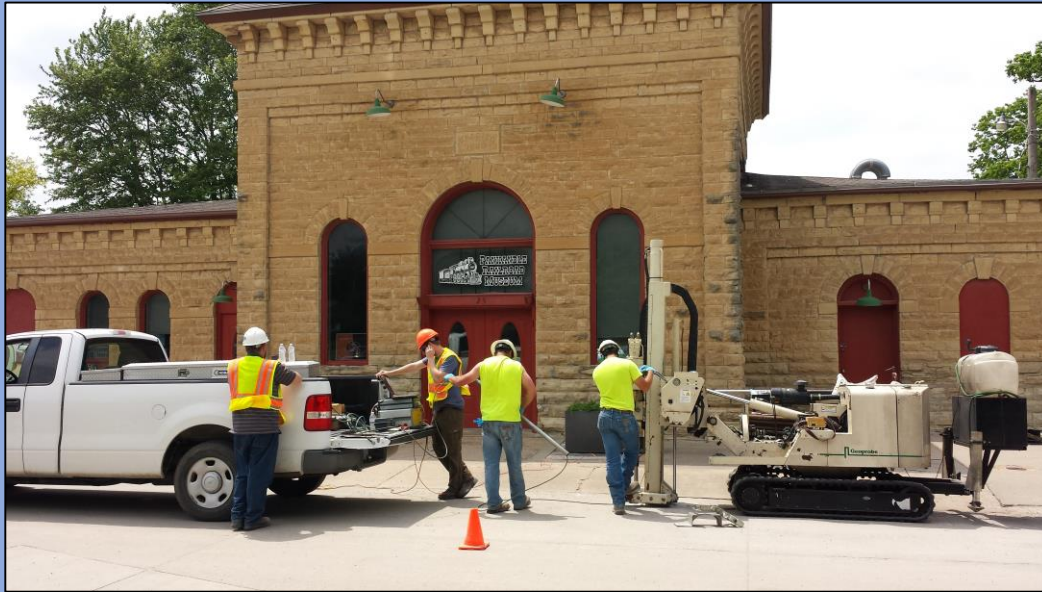
- A direct push machine is used to advance the probe into the subsurface at 2 to 4ft/min.
- A trunkline, pre-strung through the drive rods, connects the downhole probe to the up-hole electronics.
- Rods are added incrementally to the tool string as the probe is advanced.
- A still image of fluorescence and IR image of the formation is automatically captured at each rod change.

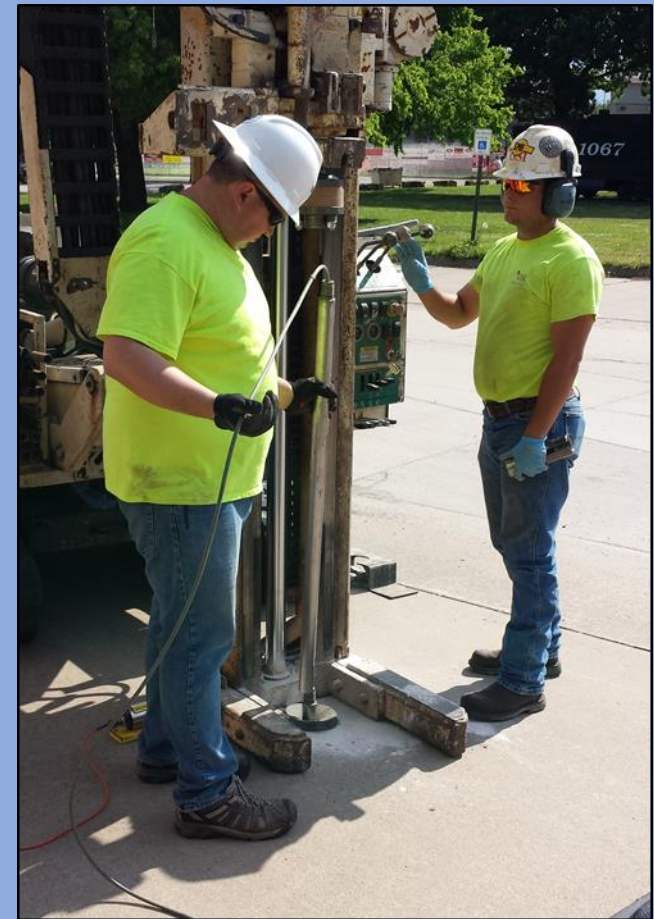
Use of drive cushion recommended for OIP logging.

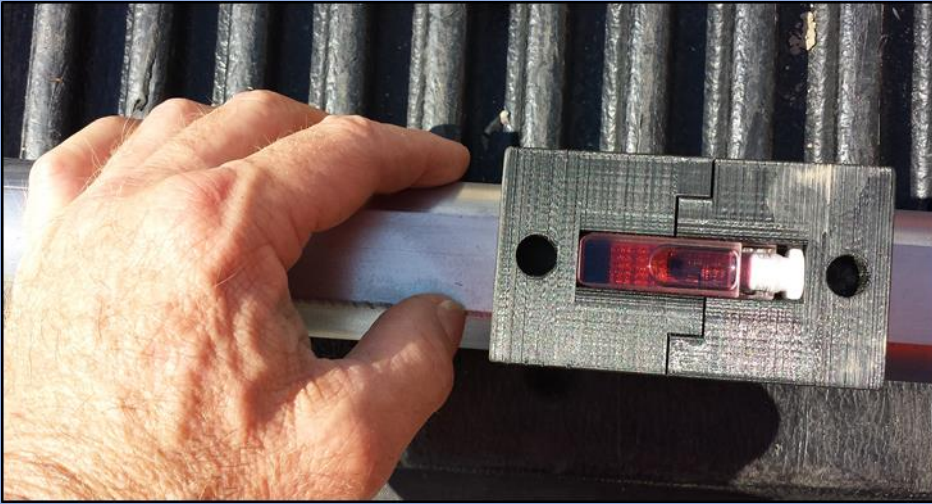
Cuvettes of know standards, typically diesel fuel and 30wt motor oil, are run before and after each log to verify performance of the optical system.

Cuvettes of site specific products may be tested.

A “black box” test is run to verify the optical cavity and window are clean and free of potential contaminants.

A visual standard is run to verify accurate color and camera focus.

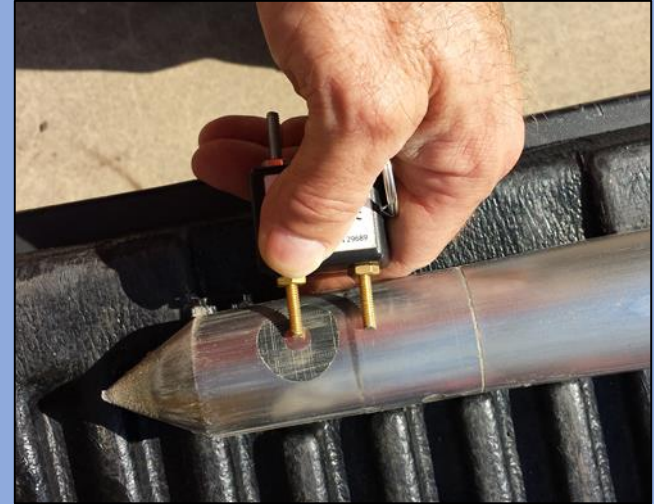
A test jig with two know conductance values is used to test and verify performance of the EC dipole and hardware before and after each log.

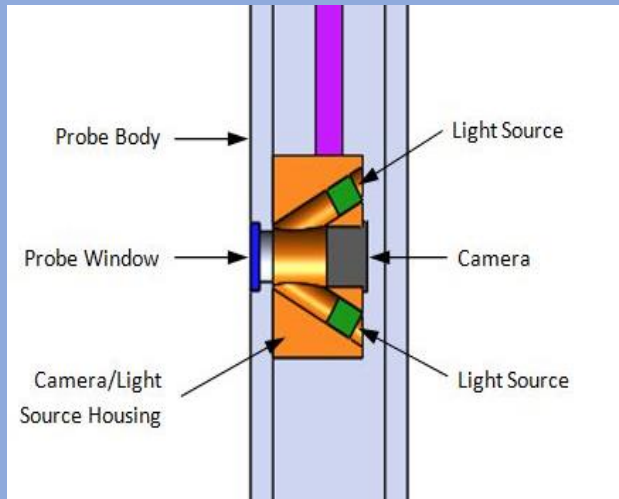
The green laser diode illuminates the formation outside the sapphire window. The CMOS camera captures images of induced fluorescence in the visible light range. The camera is the detector. One image is saved to file for every 0.05ft (~ 15mm) of log depth.

The OIP software uses a 2-stage digital filter (patent pending) to analyze the fluorescent light and determine if it falls in the correct color (hue) range above a specified brightness (value) level to be defined as fluorescence for the product under investigation. Coal tars and creosote typically fluoresce in the red-orange wavelength range.

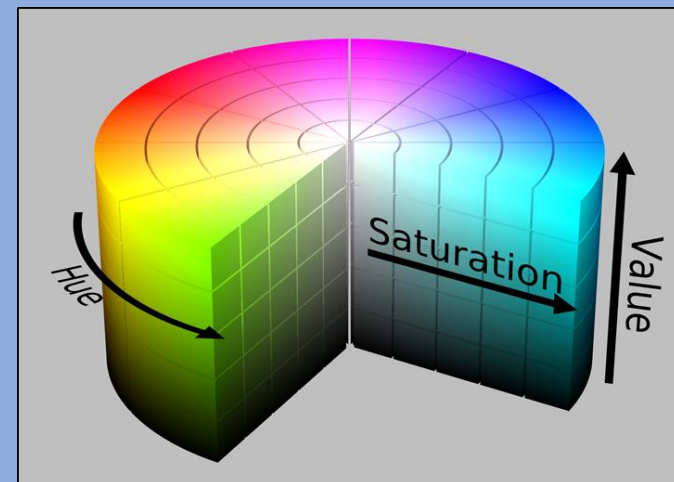
Hue, Saturation, Value (HSV) color space

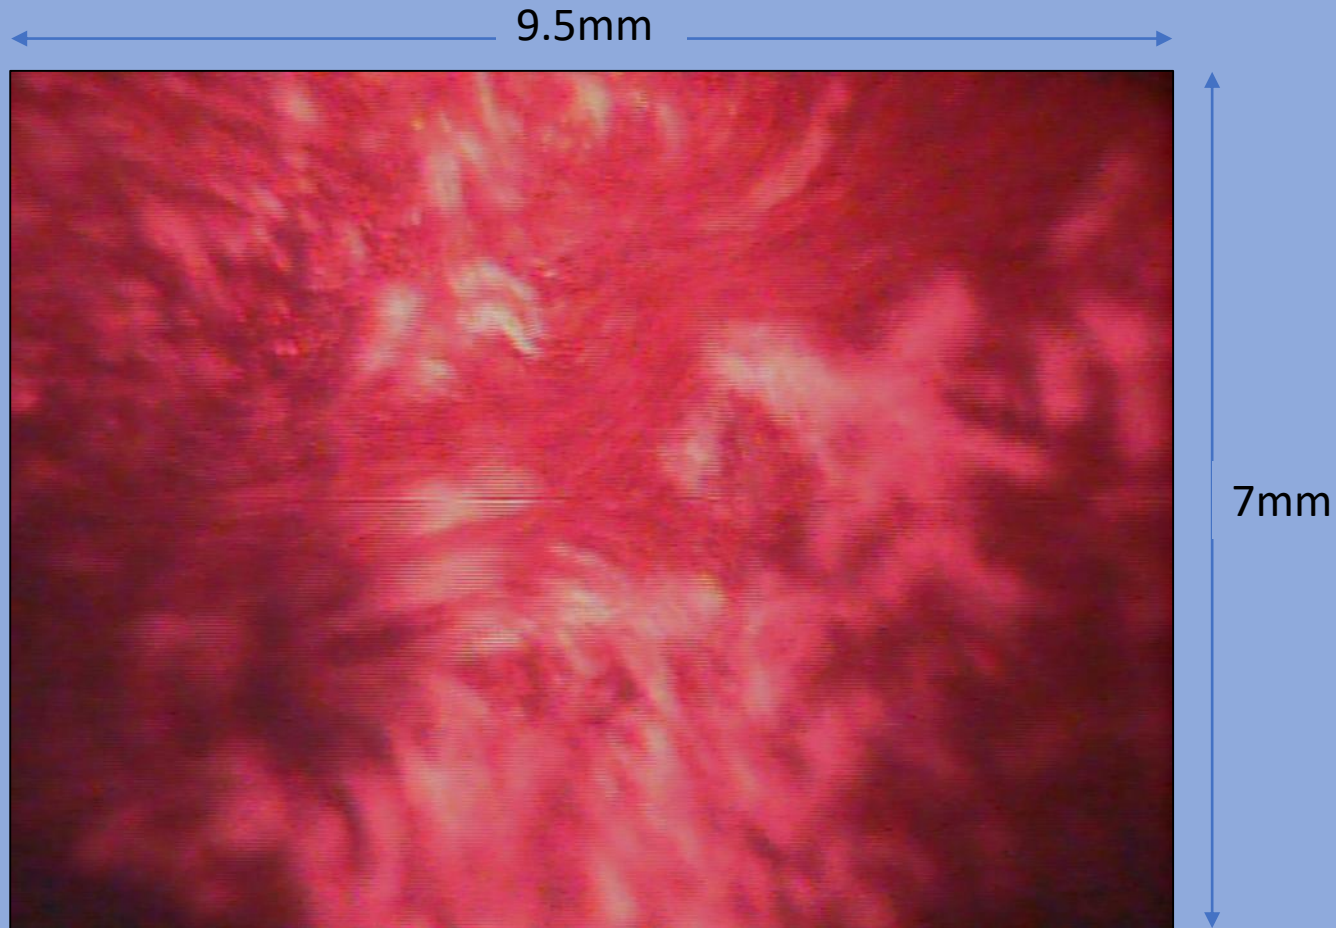
Image
Resolution is
approx. 0.3
megapixels

(640 X 480 pixels)

OIP-G image of coal tar fluorescence under the 520nm green laser diode at Wellington, KS. Location 23, 9.65 ft depth. 76.8% Area of fluorescence. Soil = 2724 mg/kg total PAH.

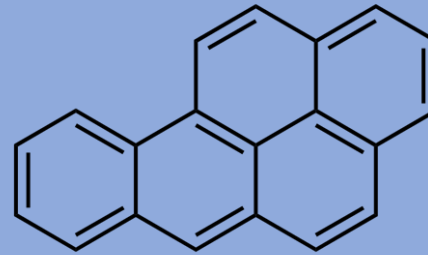
Chemical Structure of Benzo(a)Pyrene

Benzo(a)Pyrene is a polynuclear aromatic hydrocarbon (PAH) that is present in coal tar. It is a carcinogen. Coal tars contain many other PAHs including naphthalene, anthracene and pyrene. In all 14 PAHs are on the standard EPA analytical list. Many PAHs fluoresce under the green 520nm wavelength light.

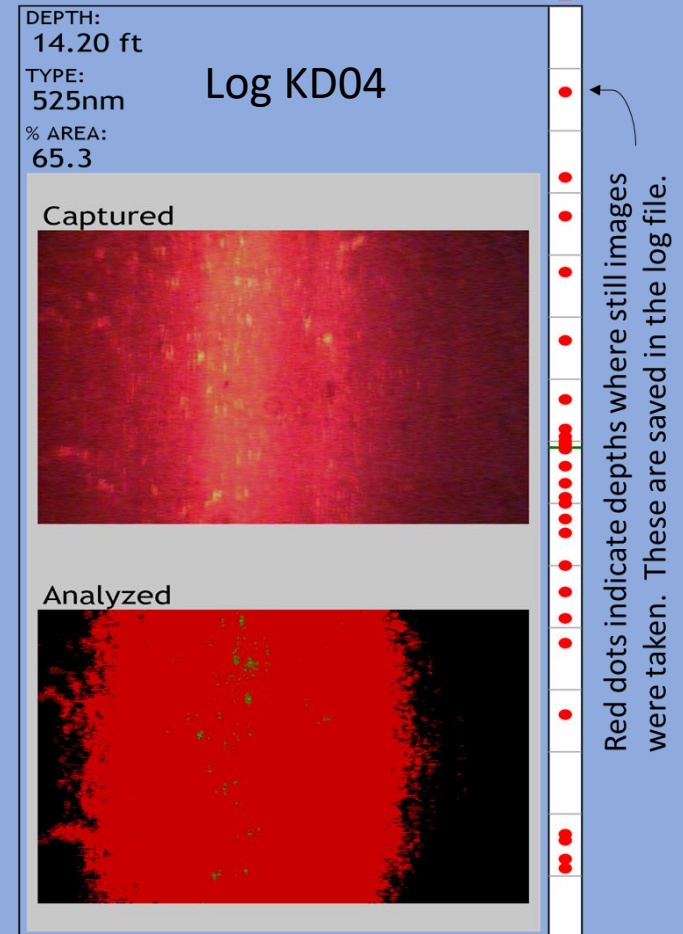
The image of fluorescence (upper) is the insitu image captured during logging. The analyzed image (lower) shows the area of image exhibiting fluorescence based on the software digital filter parameters

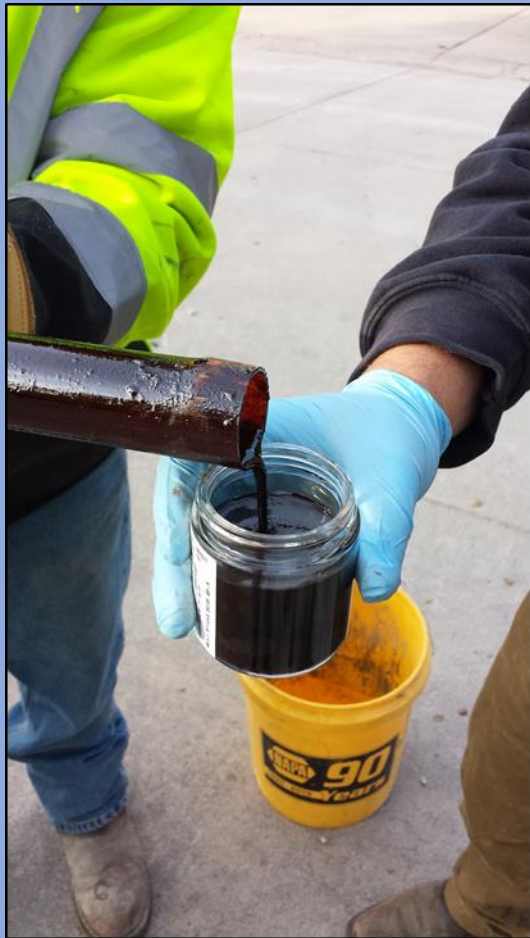
Soil Core: 13.5-17.5ft: KD04 Location

Black fluid drained from soil core in the field.

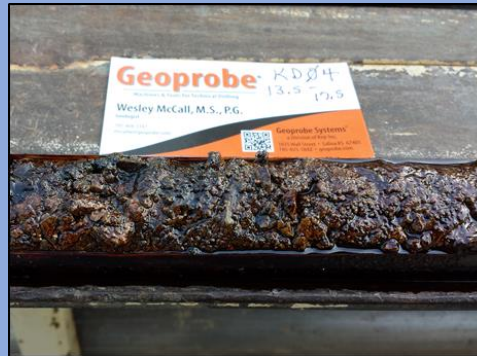
Visible coal tar fluid remains in pores of the core after fluid drained. Sand and gravel in fine matrix at about 15-16ft below grade. Confirms EC and fluorescence log and image. Lab Analysis of soil sample = 6015mg/kg total PAH.

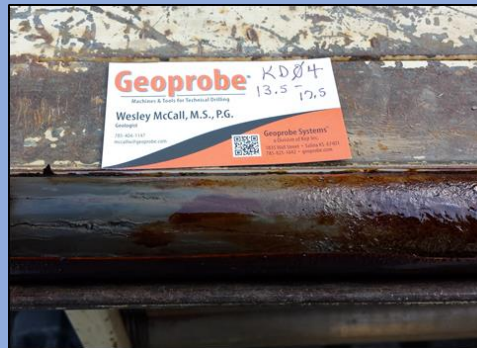
Transition from coal tar saturated coarser grained material (right) to fine grained, dark green silt-clay (left) from about 17 to 17.5ft below grade. Confirms EC and fluorescence logs.

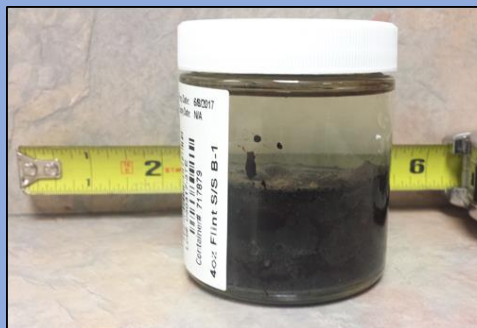
Coal tar DNAPL separated from water after sitting over night.

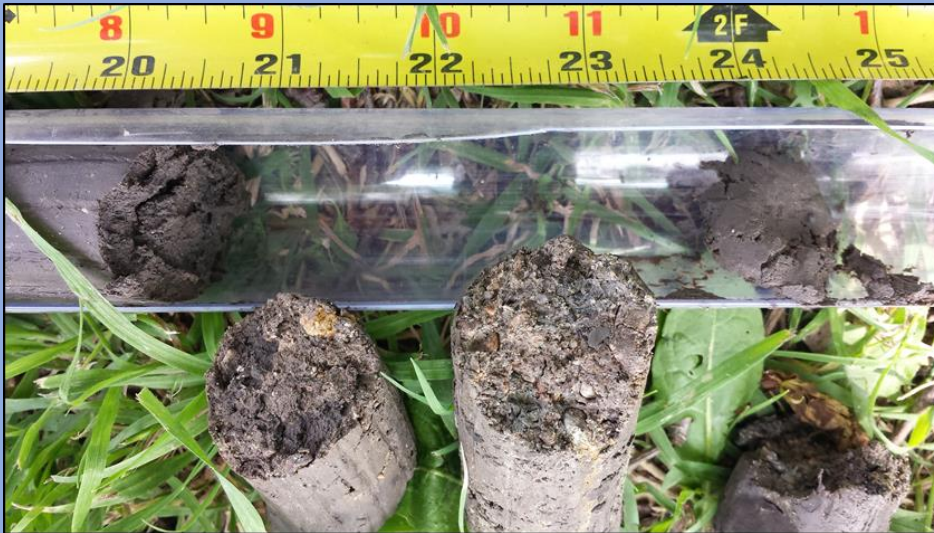
DT22 soil core from location exhibiting false positive response due to limestone clasts and caliche nodules.

Some natural minerals (e.g. calcite) and natural organics as well as man-made materials (e.g. paper) fluoresce. At the site in Wellington we discovered that caliche nodules and limestone clasts in the formation as well as limestone gravel fill exhibited fluorescence in the same wavelength range as the coal tars under the green laser diode. Targeted sampling with the DT22 coring system quickly confirmed if the observed fluorescence was due to the presence of calcite bearing minerals or coal tar contamination.

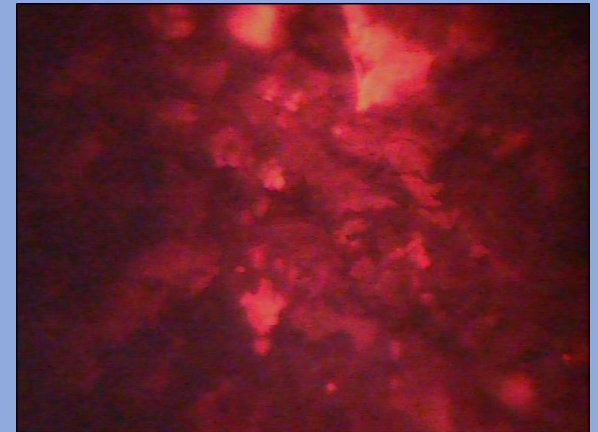
Fluorescence observed from the sample placed on the OIP window, up to 40% area of fluorescence was observed.

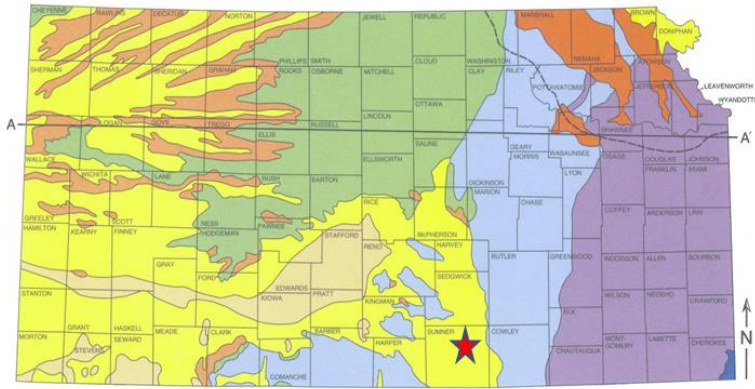
Generalized Geologic Map of Kansas

Wellington is in Sumner County, Kansas.
The local stream deposits are underlain by
Permian Age (blue) Ninnescah shale.

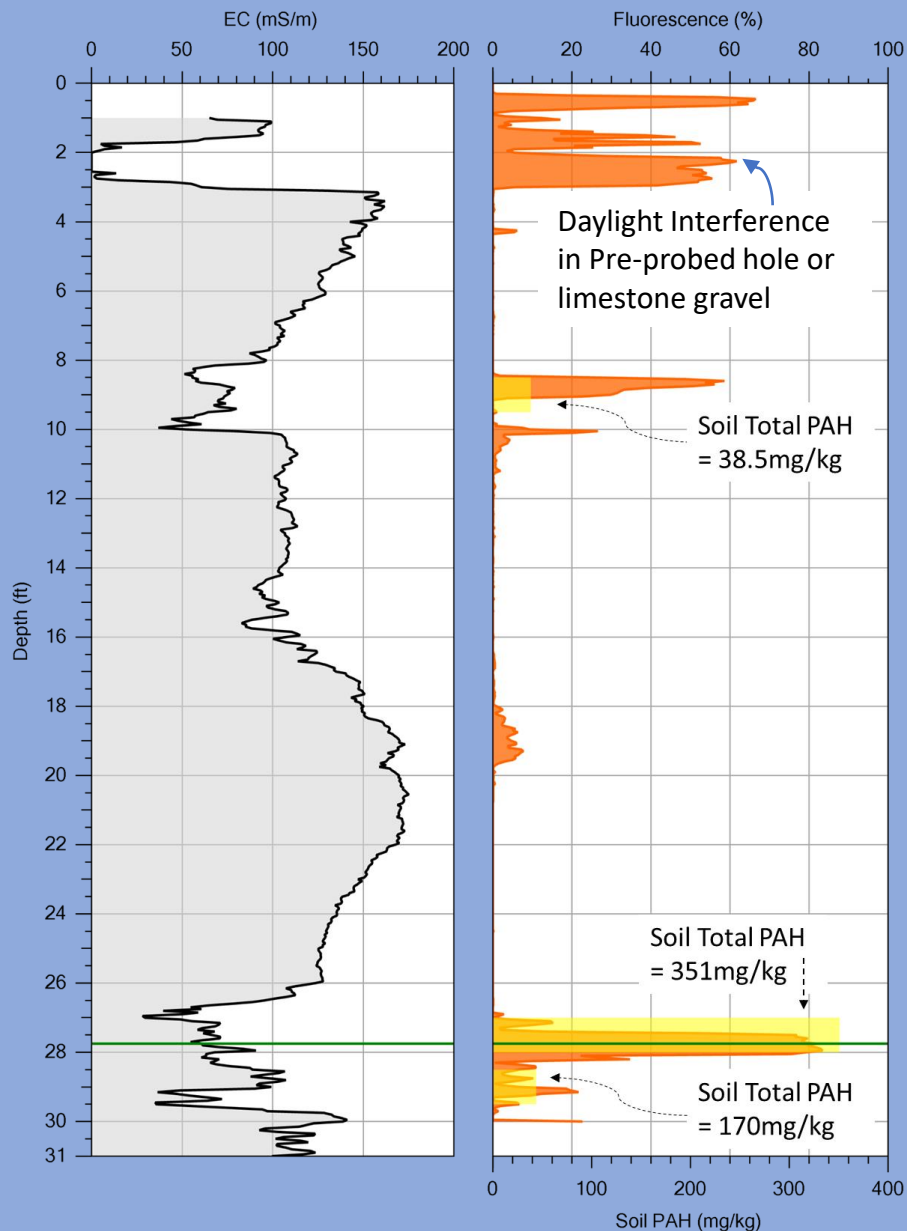
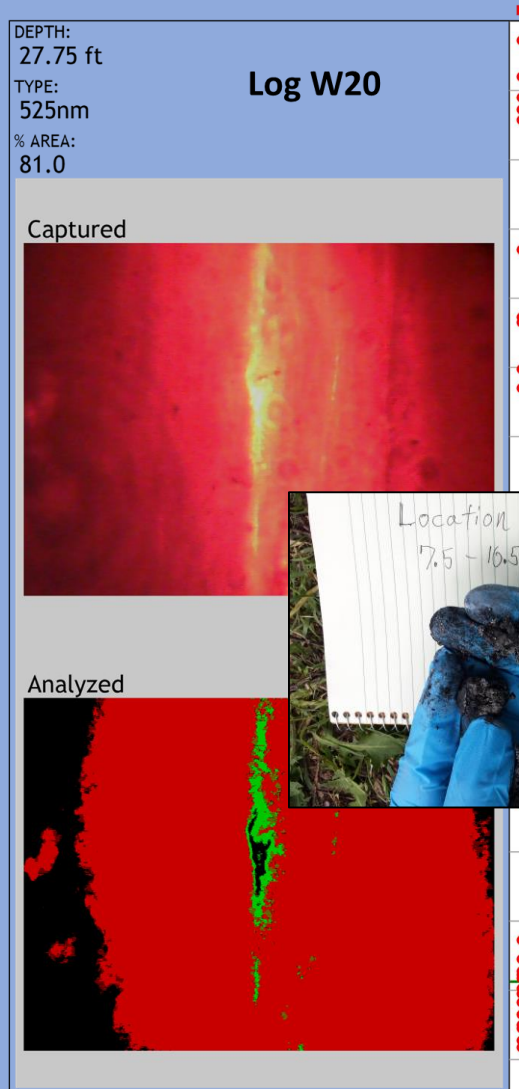
Log 20 and Sample Results

Analysis of soil samples confirm log fluorescence at three depth intervals.

Tar laden sample material from 7.5 to 10.5ft interval

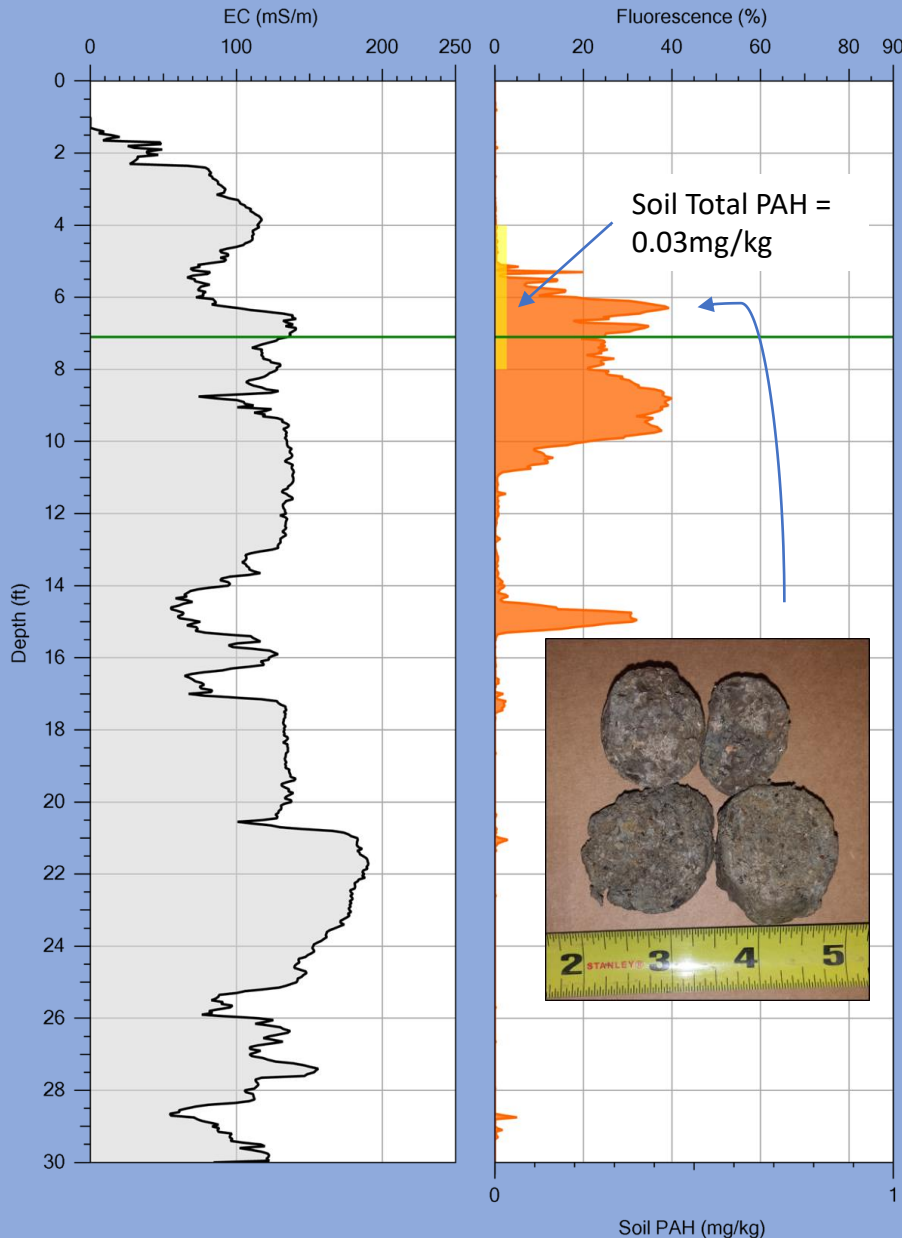
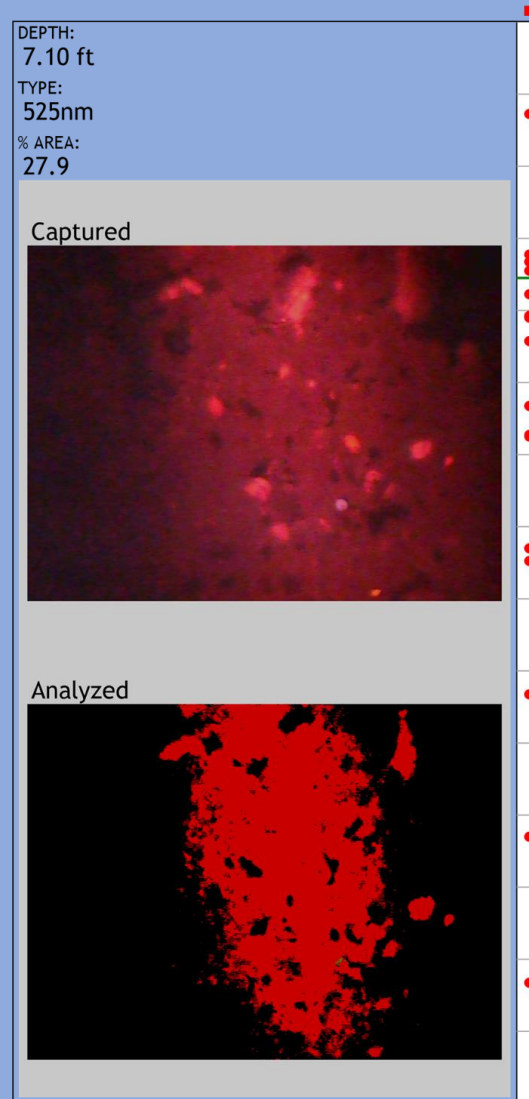
Log 17 and Sample Results: False Positive

Soil core from the 4-8ft interval displayed no visual or olfactory evidence of coal tar contamination. Lab analysis of sample for PAHs also very low. Spotty texture in captured image typical of false positive response at this site.
